Monthly Oversight Report 21
ACS NPL Site
Griffith, Indiana
August 31, 2002 - September 27, 2002

Subject: Monthly Oversight Summary Report
No. 21 for September 2002

Monthly Oversight Summary Report No. 21
ACS Superfund Site WA57, 46526.238

Reporting Period: Month of September (August 31, 2002 - September 27, 2002)
BVSPC O/S Dates: September 4, 5, 10, 12, 17, 19, 24, and 26, 2002

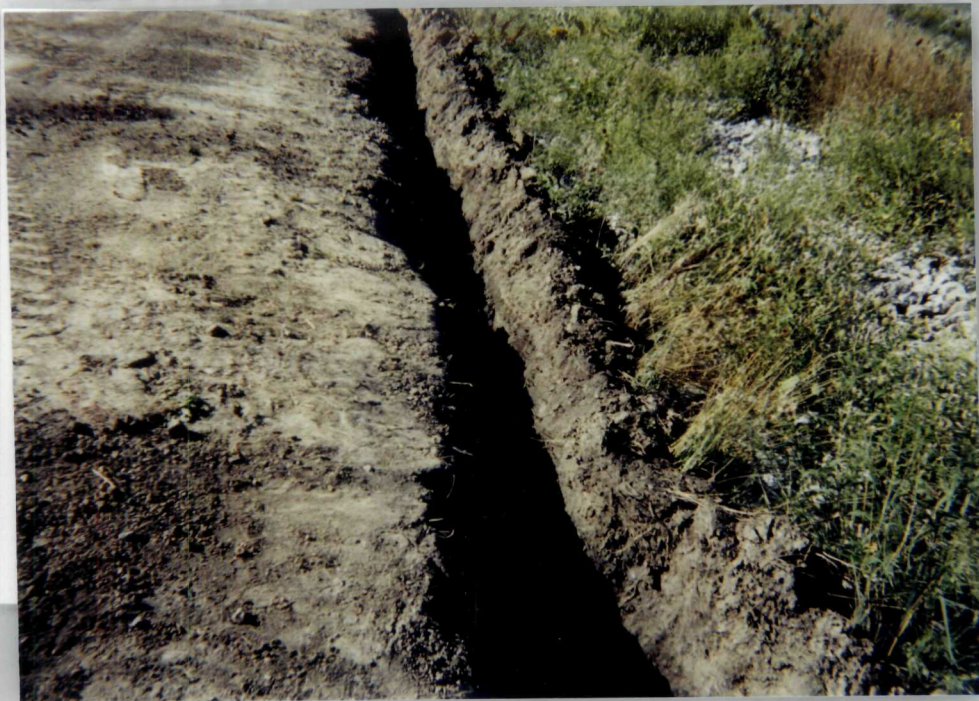
Roll: 26 Photo #1

Description: Photo facing south showing the anchor trench for the FML at the southwest corner of the OFCA.

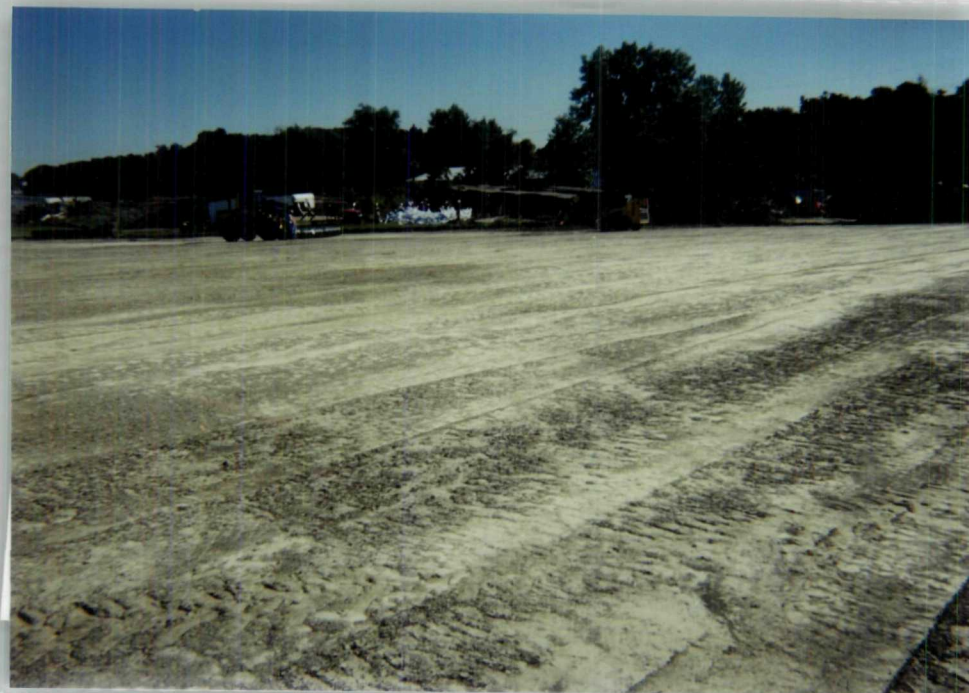
Roll: 26 Photo #6

Description: Photo facing northwest near the west side of the OFCA anchor trench looking at ground and debris that was encountered during trenching activities.

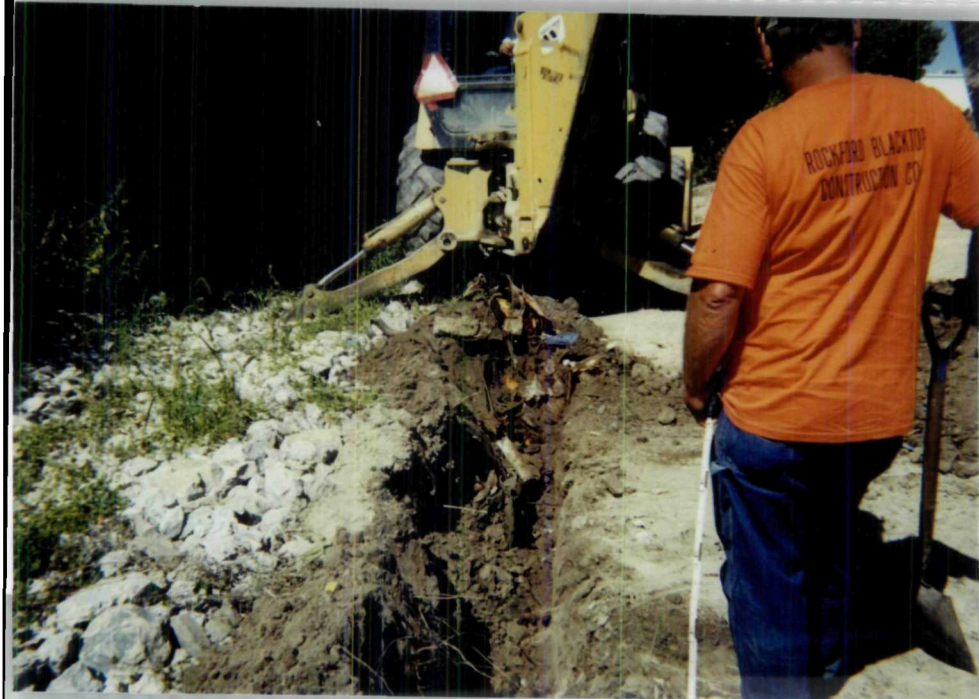
Roll: 26 Photo #7

Description: Photo facing north showing ECI trenching in line with the staked boundary of the FML at the west side of the OFCA anchor trench .

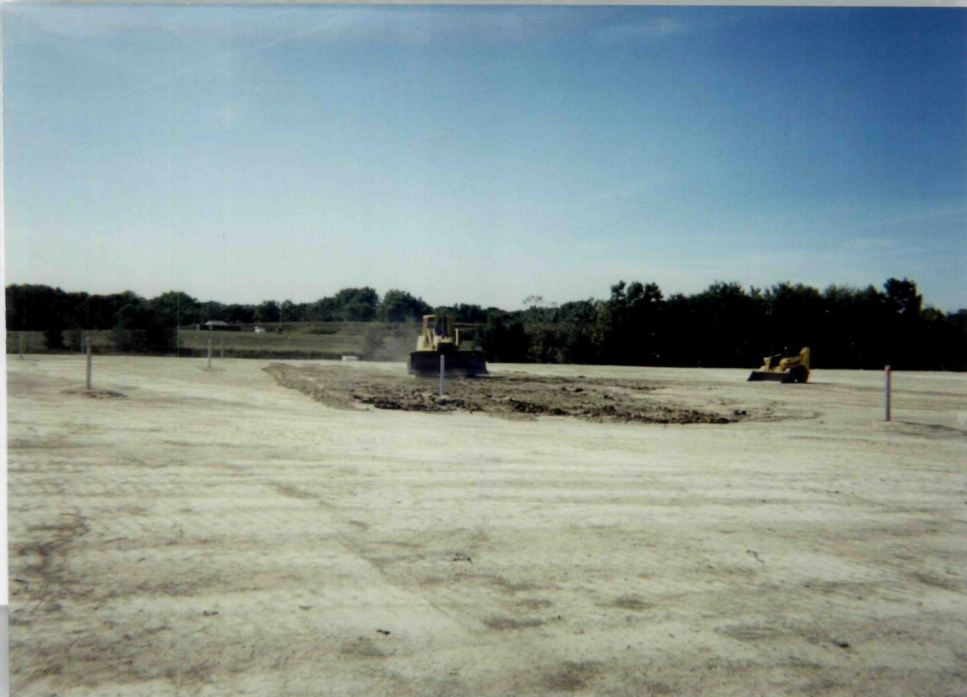
Site: American Chemical Services, Inc.
 Proj. #: 46526
 Roll: 26 Photo #9
 Date: 09-04-02 Time: 15:48
 Photographer: Chad Gailey
 Description: Photo facing west showing ECI placing clay in low areas on the Kapica-Pazmey portion of the OFCA.

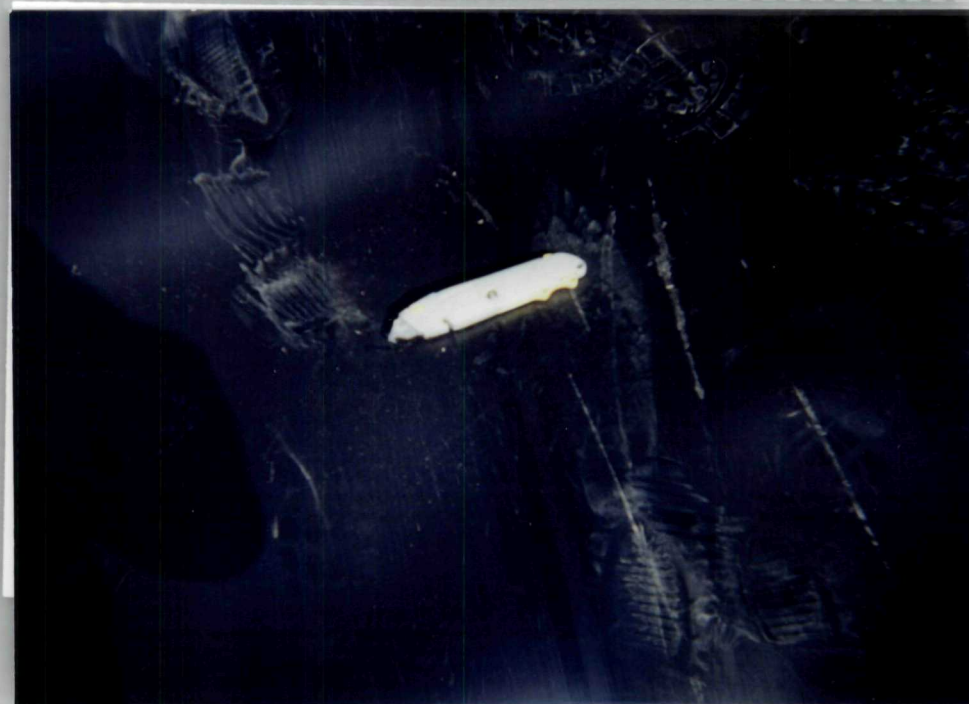
Description: Photo facing at ground showing the knife used by MAL to cut the liner. Note the notch that minimizes damaged to the underlying liner.

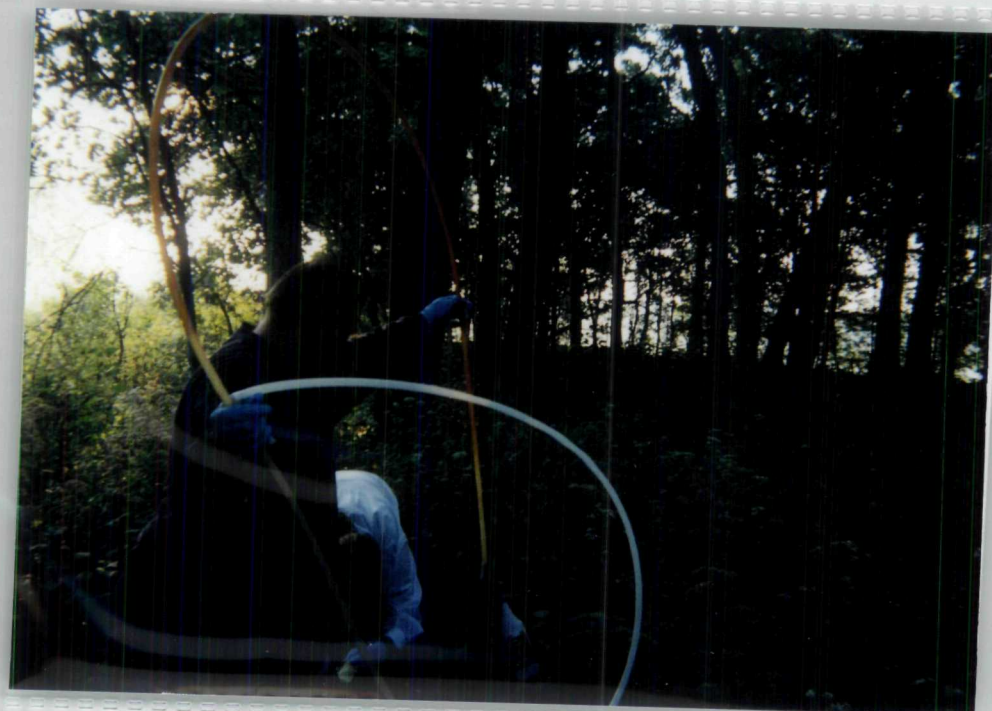
Site: American Chemical Services, Inc.
 Proj. #: 46526
 Roll: 27 Photo #1
 Date: 09-10-02 Time: 07:33
 Photographer: Chad Gailey
 Description: Photo facing east at MW11 of MWH removing the dedicated tubing out of the well in order to install the decontaminated pump.

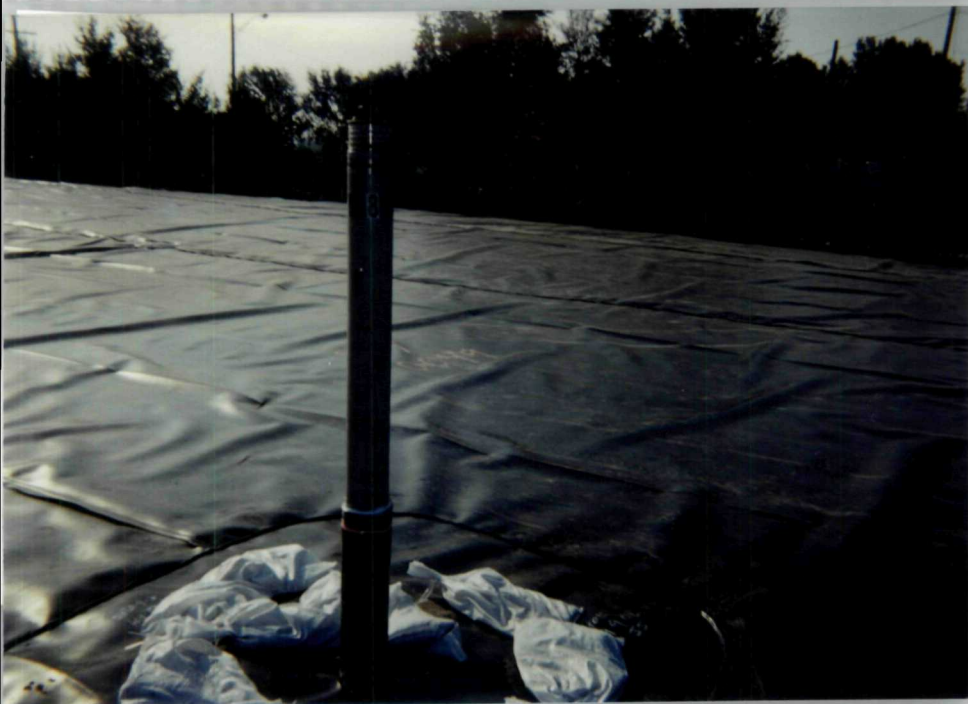
Site: American Chemical Services, Inc.
 Proj. #: 46526
 Roll: 27 Photo #6
 Date: 09-10-02 Time: 09:00
 Photographer: Chad Gailey
 Description: Photo facing southeast at OFCA ISVE
 well SVE-08 in Kapica-Pazmey area of
 the seaming and boot welding.

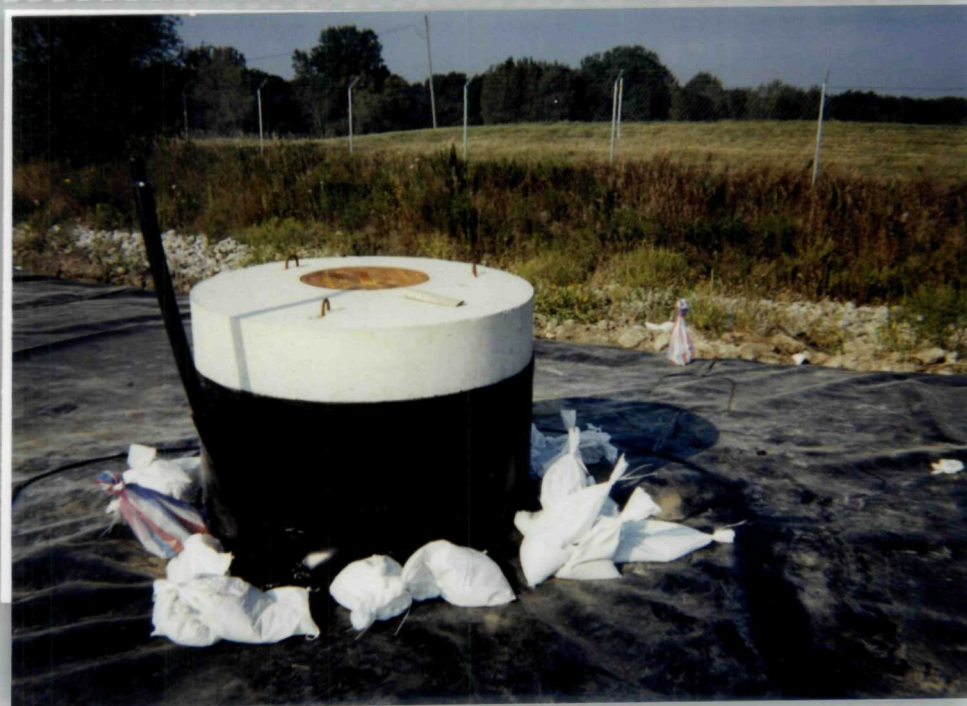
Site: American Chemical Services, Inc.
 Proj. #: 46526
 Roll: 27 Photo #7
 Date: 09-10-02 Time: 09:02
 Photographer: Chad Gailey
 Description: Photo facing southwest showing the FML
 boot at an extraction well on the OFCA
 area.

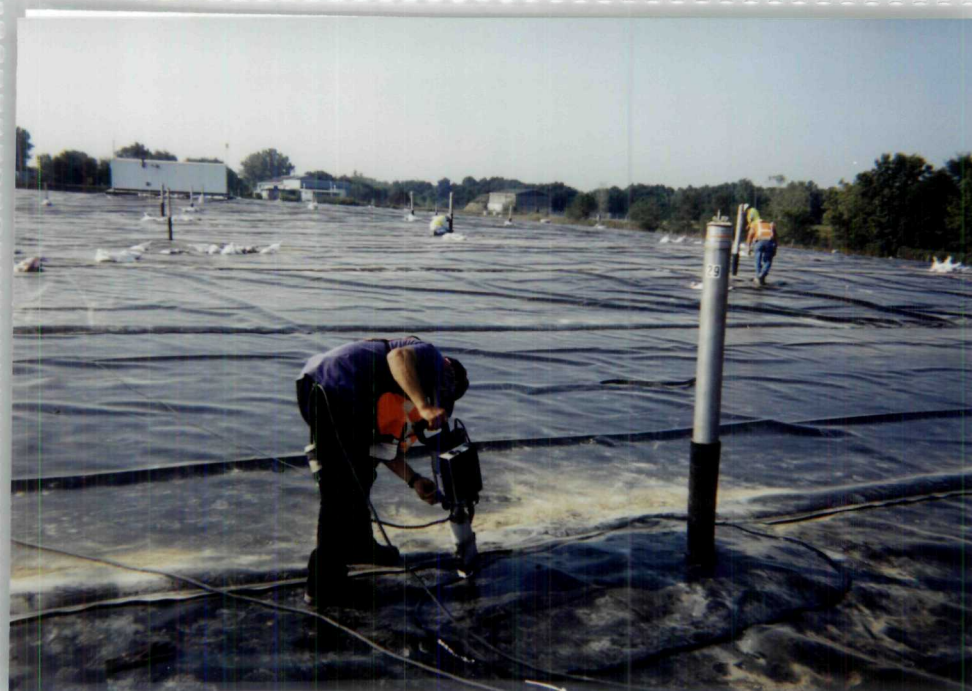
Roll: 27 Photo #10

Description: Photo facing southwest at OFCA ISVE well SVE-29 and MAL welding the boot to the FML.

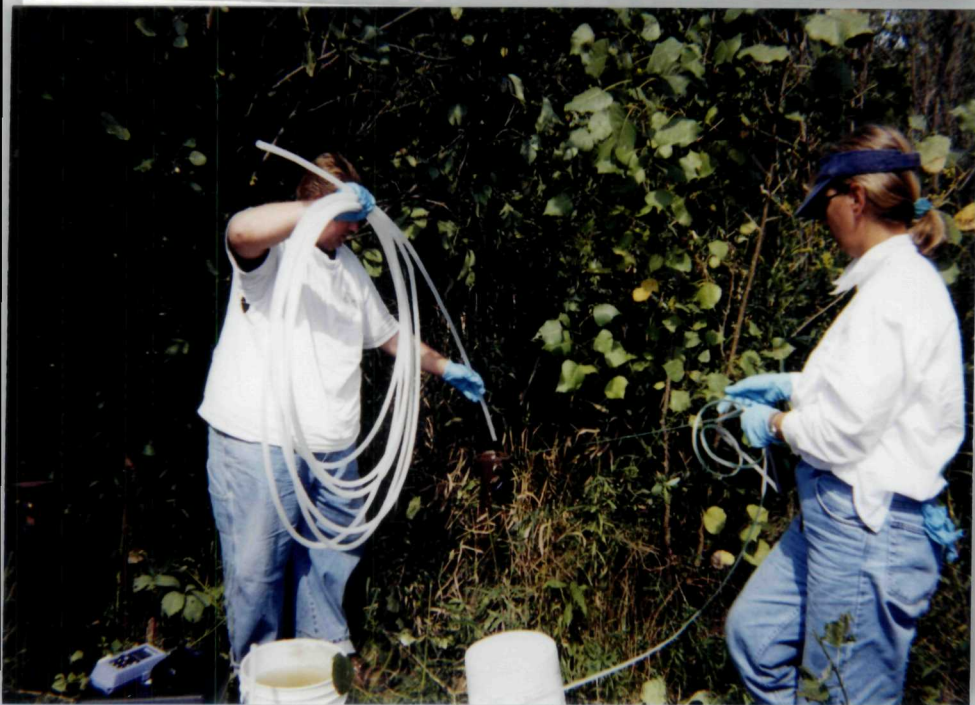
13:57 Picture 14 Roll 27 Facing North
MW30 of Ruey Labeling & Tagging
Samples.

Site: American Chemical Services, Inc.
 Proj. #: 46526
 Roll: 27 Photo #14
 Date: 09-10-02 Time: 13:57
 Photographer: Chad Gailey
 Description: Photo facing north at MW30 showing
 MWH labeling and tagging groundwater
 samples.

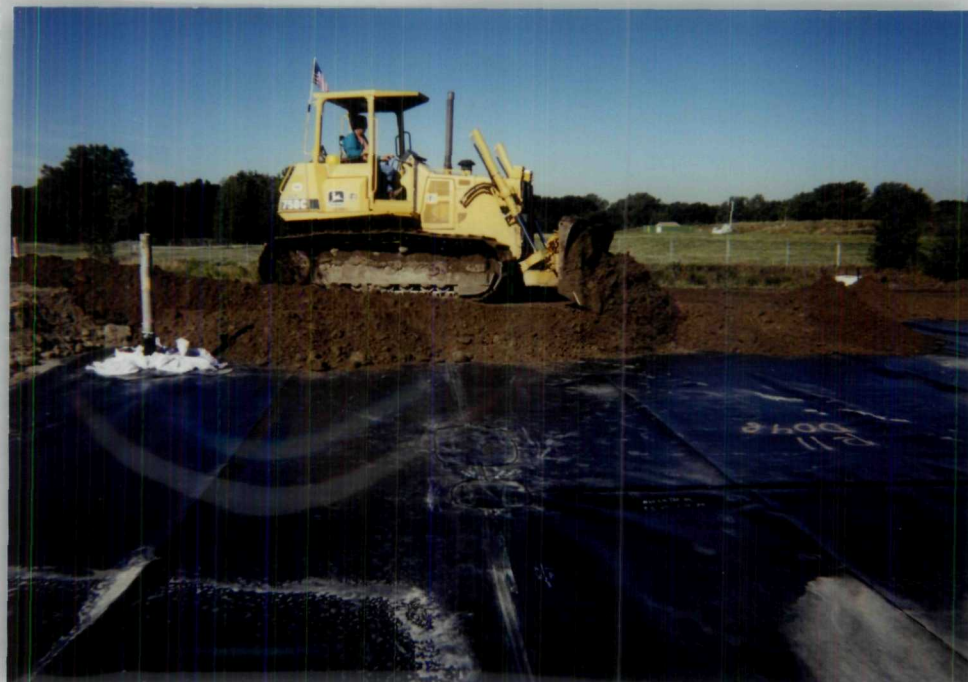
0932 Photo 21, Roll 27 Looking NE showing FML & 15VE OFCA blower shed

Site: American Chemical Services, Inc.
 Proj. #: 46526
 Roll: 27 Photo #21
 Date: 09-12-02 Time: 09:32
 Photographer: Larry Campbell
 Description: Photo facing northeast showing the FML
 and OFCA ISVE blower shed.

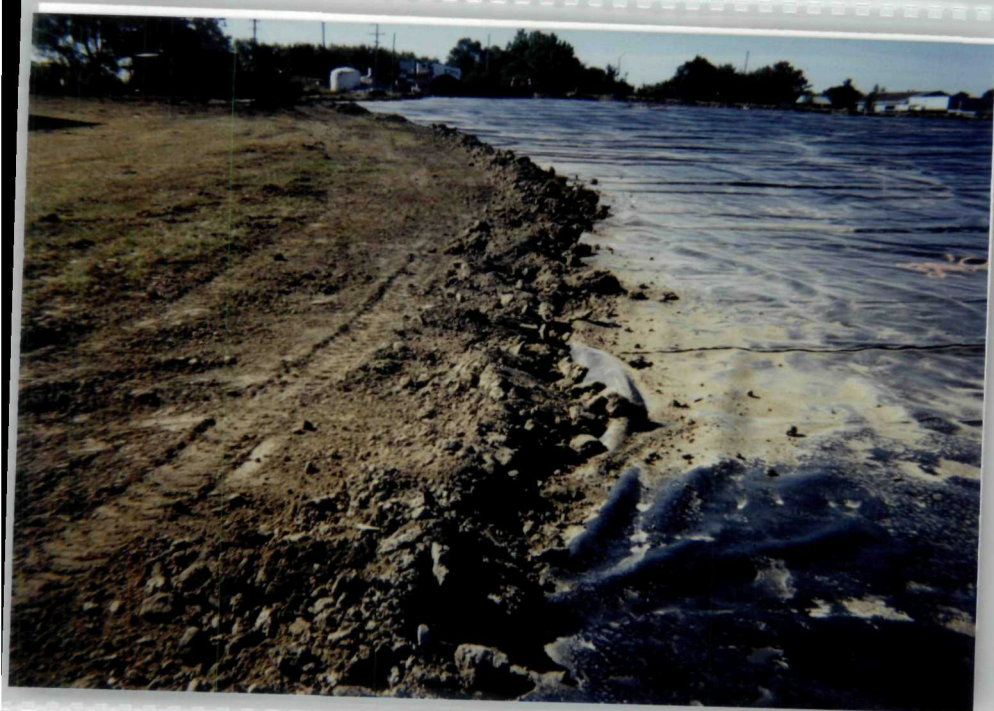
0935 Photo 22, Roll 27 Looking W showing Spreading of Sand cap over FML in KPA area

Site: American Chemical Services, Inc.
 Proj. #: 46526
 Roll: 27 Photo #22
 Date: 09-12-02 Time: 09:35
 Photographer: Larry Campbell
 Description: Photo facing west showing ECI spreading
 sand over the FML in the Kapica-Pazmey
 area.

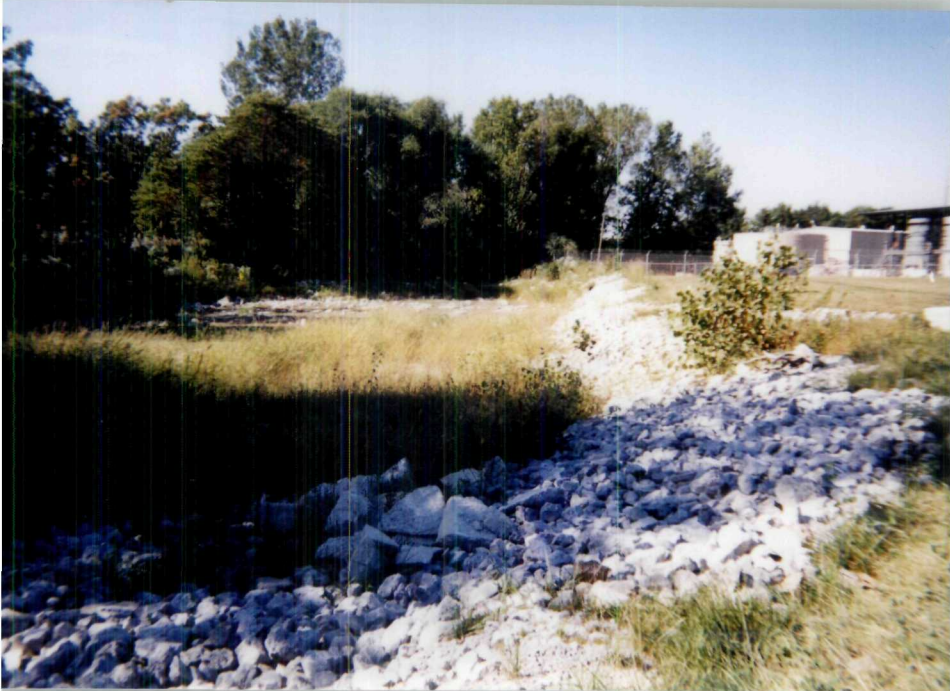
Description: Photo facing southwest showing ECI dumping root zone material along the east side of the OFCA engineered cover.

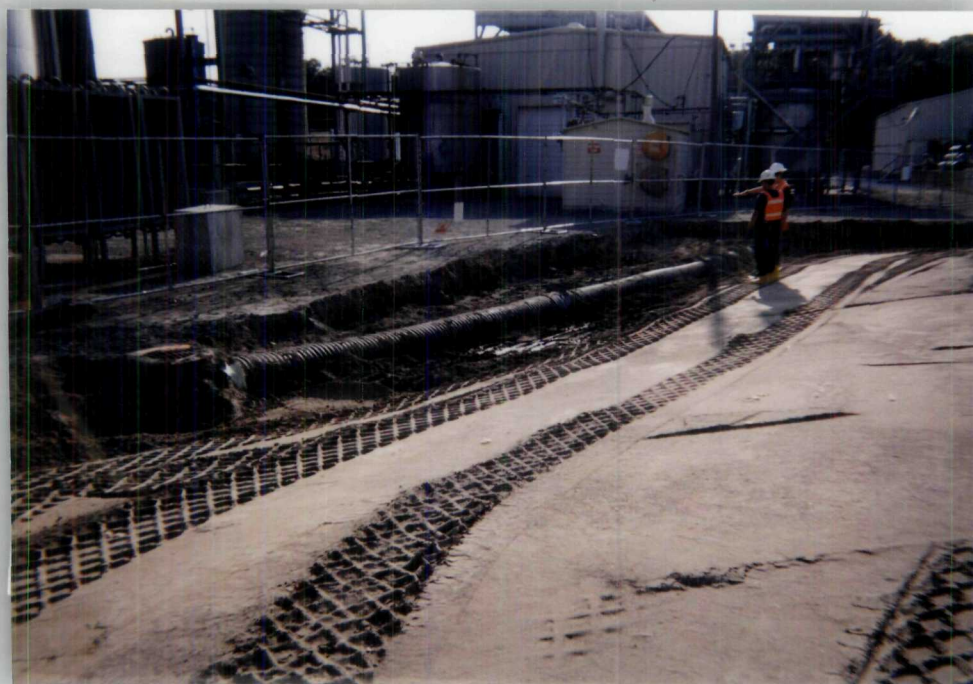
0825 Roll 18 Photos 15 & 16 facing north at ground near ACS employee breakroom at voids. Roll 18 Photo 17 facing north at debris and voids in subbase. PID readings in voids around 10 ppm, but breathing zone PID at 0.1 ppm.

Site: American Chemical Services, Inc.
 Proj. #: 46526
 Roll: 28 Photo #17
 Date: 09-19-02 Time: 08:25
 Photographer: Leigh Peters
 Description: Photo facing north of debris and voids in
 the ONCA SBPA subgrade.

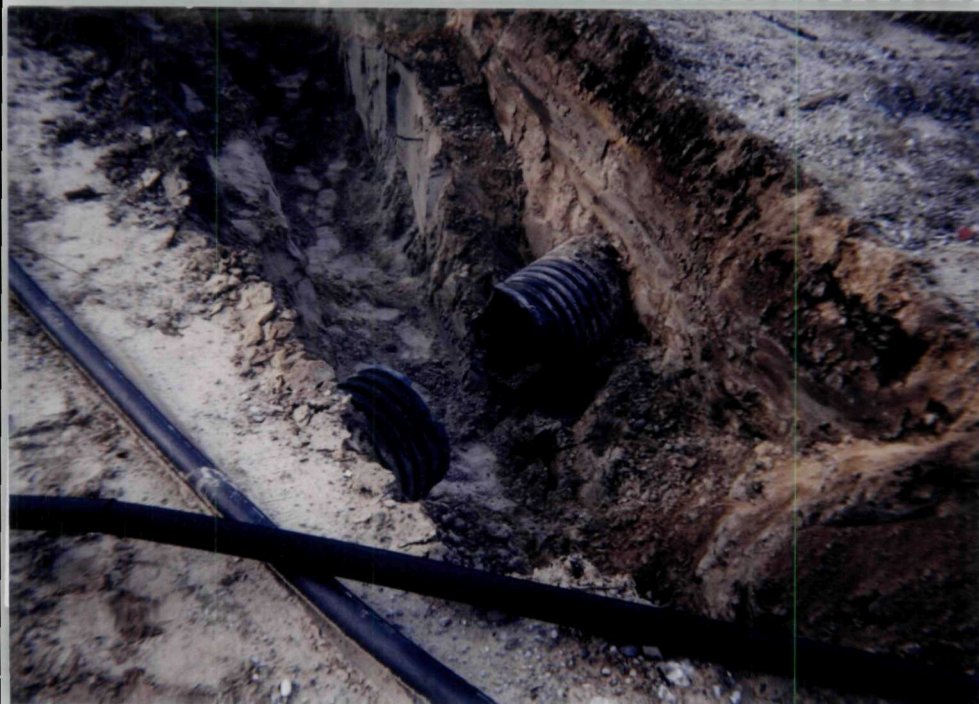
0845 Roll 25 Photo 18 facing northeast of ACS storm drain and area of revised cut as shown on pg 8.

Site: American Chemical Services, Inc.
 Proj. #: 46526
 Roll: 28 Photo #18
 Date: 09-19-02 Time: 08:45
 Photographer: Leigh Peters
 Description: Photo facing northeast of the ACS storm
 drain piping and location where the ONCA
 SBPA interim cover construction will be
 revised.
